## Re: Missing and sub-standard pedestrian connections in the Central & Western District

Encl. List of 15 missing links responses

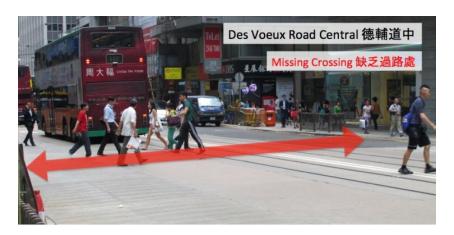
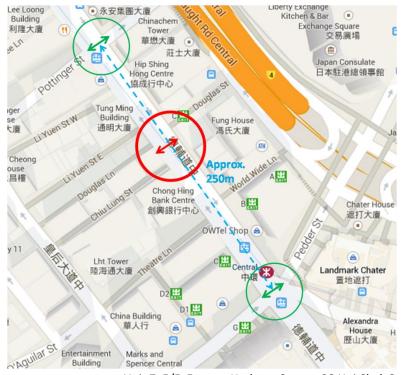
1. Location: Des Voeux Road Central

**Problem: Missing crossing**

Although there are currently two crossings (indicated as green arrows on the map below) on Des Voeux Road Central near the junction with Pedder Street and one near Pottinger Street, it is insufficient as the distance is about 250m. There is an obvious demand as pedestrians are crossing illegally all the time. We suggest adding a crossing (red arrow) at the middle of Des Voeux Road Central that is near the Hong Kong Station Exit C in order to reduce the demand for jay-walking. Relocation of nearby bus stops may be needed.

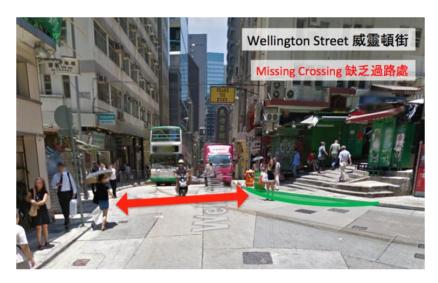
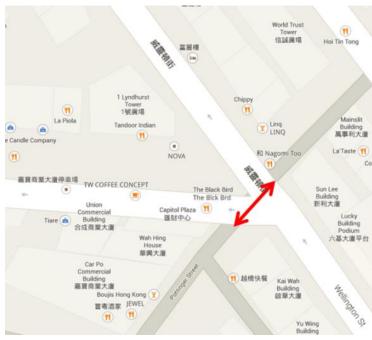
## 2. Location: Junction of Wellington Street and Lyndhurst Terrace

**Problem: Missing crossing**

Thank you for acknowledging the demand for crossing is ineffectual. Although the junction is on a generally one-way street, it is an unsafe and informal crossing due to high volume of traffic flow with buses and goods vehicles. The concerned location is a tourist spot that attracts many sightseers thus there is high pedestrian flow. Crossing should be properly marked to connect with Pottinger Street. We suggest enlarging the width of the footpath as indicated (green) in the photo below and adding a zebra crossing with dropped kerb to provide a safe and barrier-free access crossing for pedestrians.

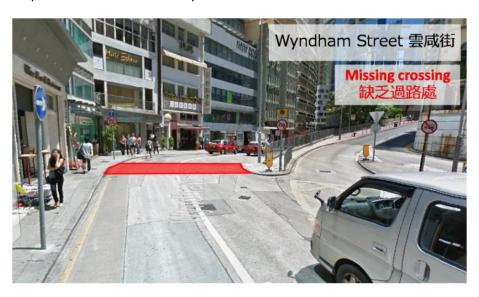
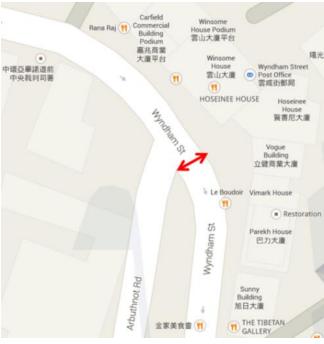
## 3. Location: Intersection of Wyndham Street and Arbuthnot Road

**Problem: Missing crossing**

As the concerned location has high volume of traffic flow, it is difficult for pedestrians to cross the road safely. The suggested solution of using the public passageway which is located within the Centrium is inconvenient to pedestrians. There needs to be a non-standard solution, which is adding a zebra crossing as indicated (red) in the photo below. This would provide a more convenient way for pedestrians to access to Wyndham Street from Arbuthnot Road.

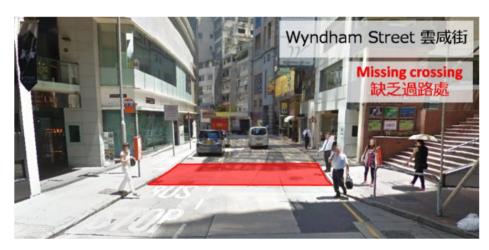
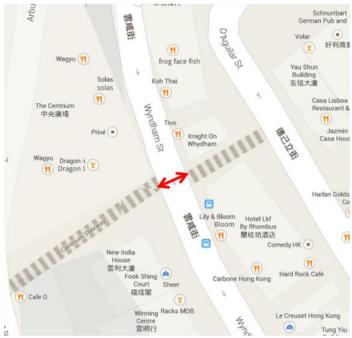
4. Location: Wyndham Street and Centrium Stairway

**Problem: Missing crossing**

Thank you for acknowledging that there is no site constraint limiting the sightline. Although the concerned location is a one-way street, there is high traffic flow making it difficult for pedestrians to cross the road safely. The signal controlled crossing at the junction of Wyndham Street/ Glenealy/ Lower Albert Road is inconvenient to pedestrians who want to access to Centrium Stairway directly. We suggest adding a zebra crossing with Belisha beacon at the indicated location (red) in the photo below to connect Yau Shun Building with the Centrium Stairway. Relocation of the nearby bus stop may be needed.

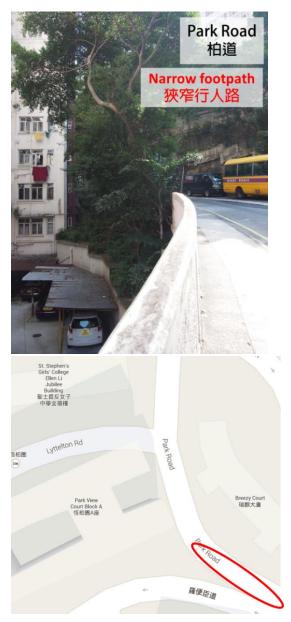
5. Location: Park Road

**Problem: Narrow footpath**

The narrow footpath problem has been a daily problem to the residents and students from the nearby schools for many years. The concerned location is dangerous and not pedestrian-friendly. The narrow footpath only allows pedestrians to walk in single file and they have to walk very carefully due to the high traffic flow with many buses passing by. Therefore, we urge Transport Department to provide a safe footpath. Since the agreement of Breezy Court's lot owners have not been acquired, what measures will the Transport Department implement to address the safety concerns?

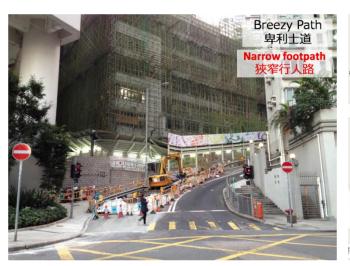
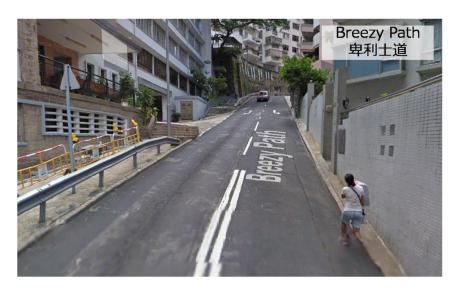
6. Location: Breezy Path Problem: Narrow footpath

The footpath is missing on the west and very narrow on the east that causes danger to pedestrians. As stated by the Education Bureau [LC Paper No. CB(2)1756/11-12(01)], the site at 2 Breezy Path will be demolished and become the extension of Ying Wa Girls' School under their redevelopment project. Is it feasible to set back the building and realign the road, so as to widen the footpath on both sides? Alternatively, is it feasible to remove the staircase on the west and realign the road to widen the footpath on the east? Since the concerned location is on slope, reducing traffic speed is also needed to ensure the safety of pedestrians.

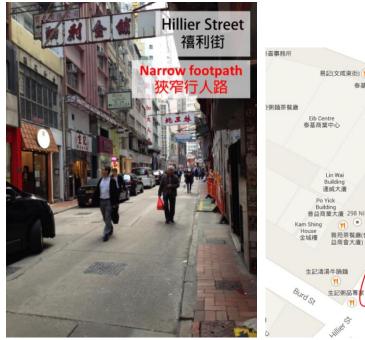
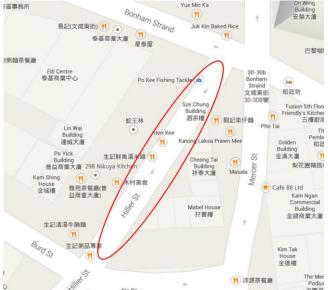
7. Location: Hillier Street Problem: Narrow footpath

Pedestrian flow and usage rate of on-street parking are high. With the relatively low traffic flow, shared use of the road space by vehicles and pedestrians should be actively studied. Footpath can be levelled down and road markings or signs for cars to slow down can be implemented. Bollards can be placed to avoid the share space being excessively occupied by the vehicles. The whole scheme will enhance the walkability of pedestrians. What are the specific reasons of not supporting the shared space concept?

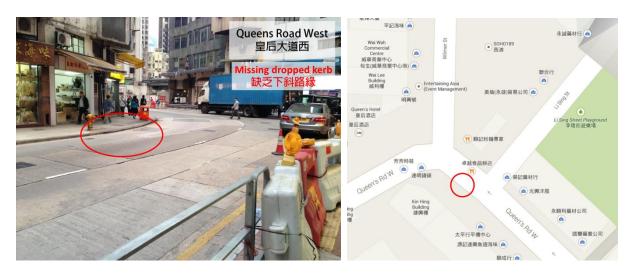
9. Location: Queen's Road West (near Li Sing Street)

Problem: Missing dropped kerb

Dropped kerb is still missing. When will the works begin?

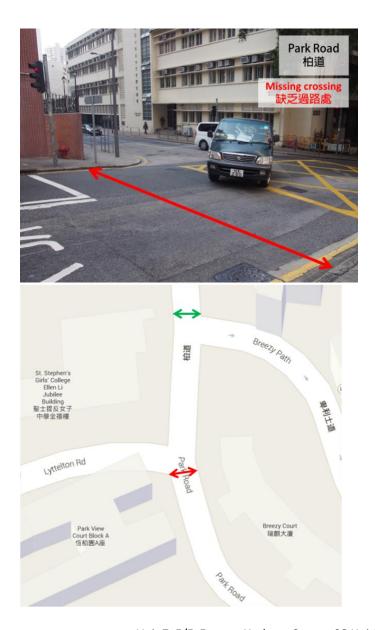
## 10. Location: Intersection of Park Road and Lyttelton Road

**Problem: Missing crossing**

Pedestrian flow is high during peak hours because it is at a school zone and a residential area. The existing signalised pedestrian crossing (green arrow in the map below) near the junction between Park Road and Breezy Path is inconvenient and not easily accessible for pedestrians who walk from Robinson Road to Lyttelton Road. Therefore, we suggest adding a cautionary crossing with "Look Left/Right" road markings at the concerned location (red arrow in the map below) in order to provide a convenient and direct way for pedestrians to cross the road safely.

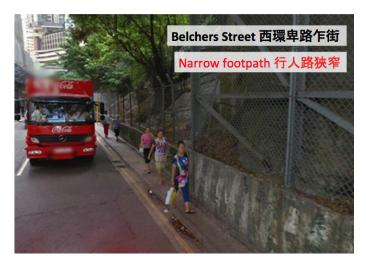
12. Location: Belcher's Street Problem: Narrow footpath

Pedestrian flow is high and widening the footpath is required. What measures will the Transport Department implement to address the demand and provide a wider footpath for pedestrians?

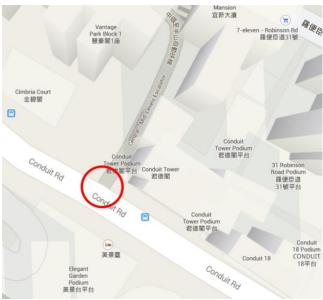
14. Location: Conduit Road Escalator Exit Problem: Sub-standard footpath

This escalator is heavily used by pedestrians on a daily basis. It is important to provide a safe pavement around the entrance area. In order to protect the safety of pedestrians and to provide a barrier-free access, filling up the level difference is recommended. At this moment, the coloured strip at the edge of pavement area outside the escalator is not obvious and cannot draw pedestrian's attention.

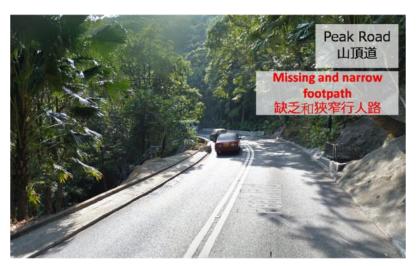
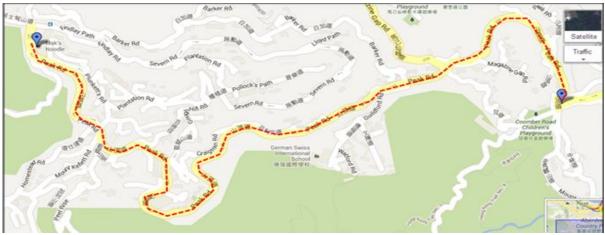
17. Location: Peak Road

Problem: Missing and narrow footpath

The narrow and intermittent footpath at Peak Road with high traffic volume may cause danger to pedestrians. We urge Transport Department to implement a program for improvement when there are slope works. Can the Transport Department provide the details of the scheduled slope works at the concerned location and provide a standardized footpath?
