中西區區內不合標準和缺乏連接的行人路

Missing and sub-standard pedestrian connections in the Central & Western District

Encl. Maps and photos of 18 Missing Links

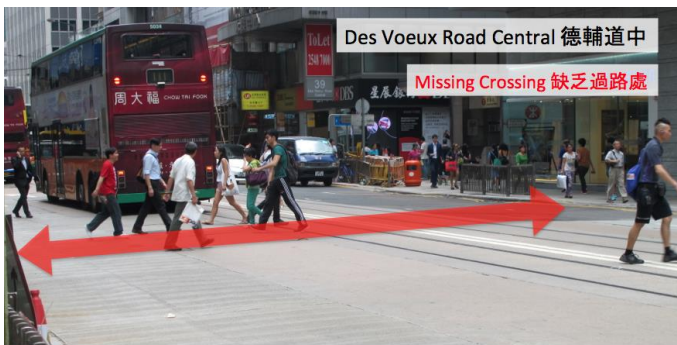
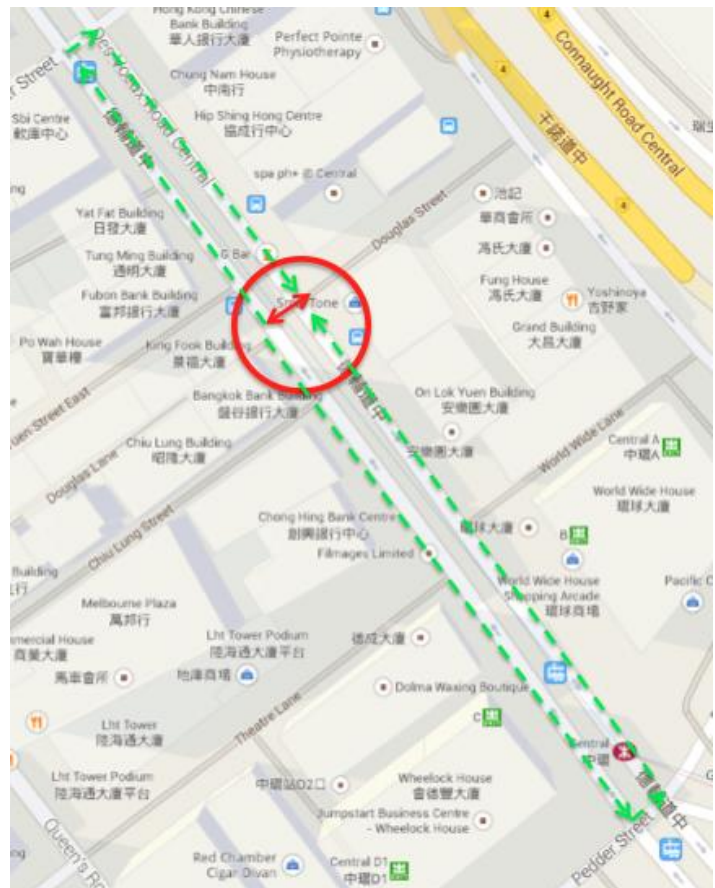
1.
 Location: Des Voeux Road Central
 Problem: Missing Crossing
 Description: There is no at grade crossing, encouraging pedestrians to jay-walk
 Suggestion: Provide crossing

- 位置: 德輔道中
 問題: 缺乏過路處
 詳情: 缺乏過路處, 令行人在該處亂過馬路
 建議: 提供過路處

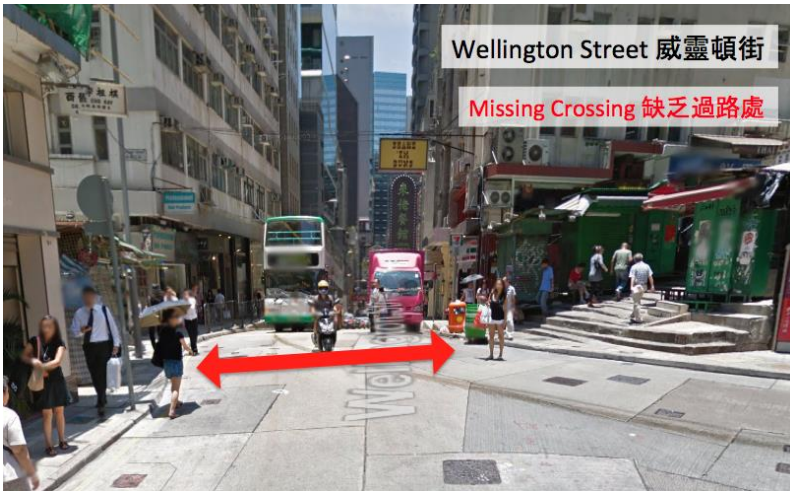
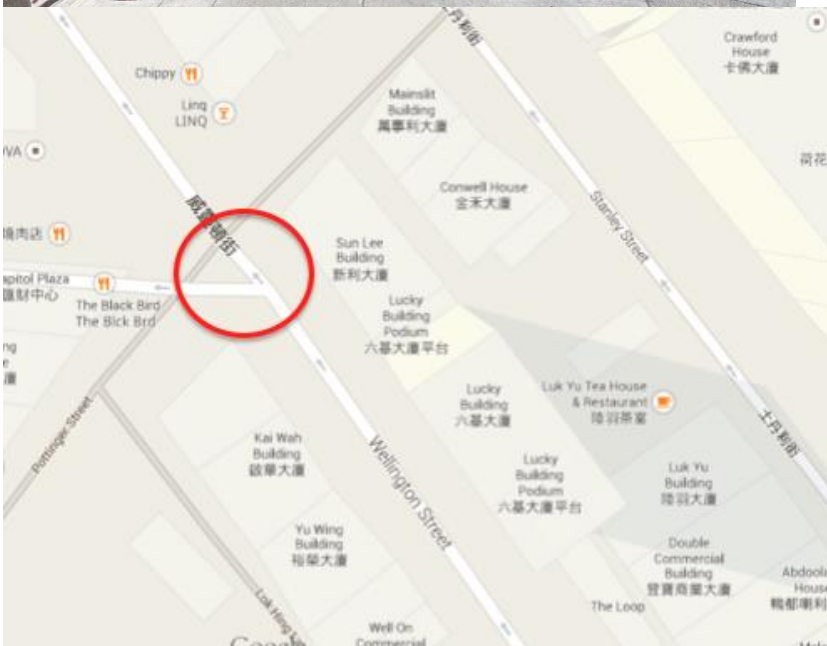
2.
Location: Junction of Wellington Street and Pottinger Street
Problem: Missing Crossing
Description: No crossing to connect the two sides and this is a high traffic area
Suggestion: Provide crossing

- 位置: 威靈頓街與砵甸乍街交界
問題: 缺乏過路處
詳情: 缺乏過路處及路段交通繁忙
建議: 提供過路處

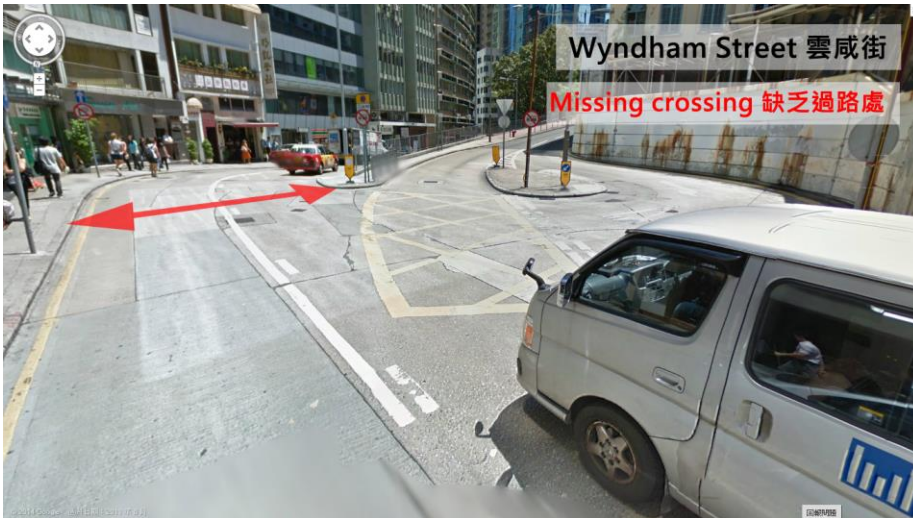
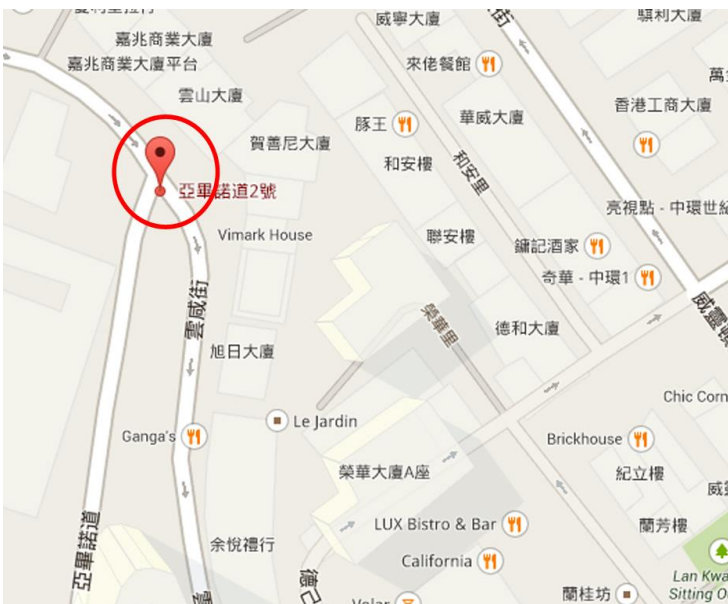
3.
Location: Intersection of Wyndham Street and Arbuthnot Road
Problem: Missing Crossing
Description: Missing crossing connection between Wyndham Street and Arbuthnot Road
Suggestion: Provide crossing

- 位置: 雲咸街與亞畢諾道交界
問題: 缺乏過路處
詳情: 缺乏過路處連接雲咸街與亞畢諾道
建議: 提供過路處

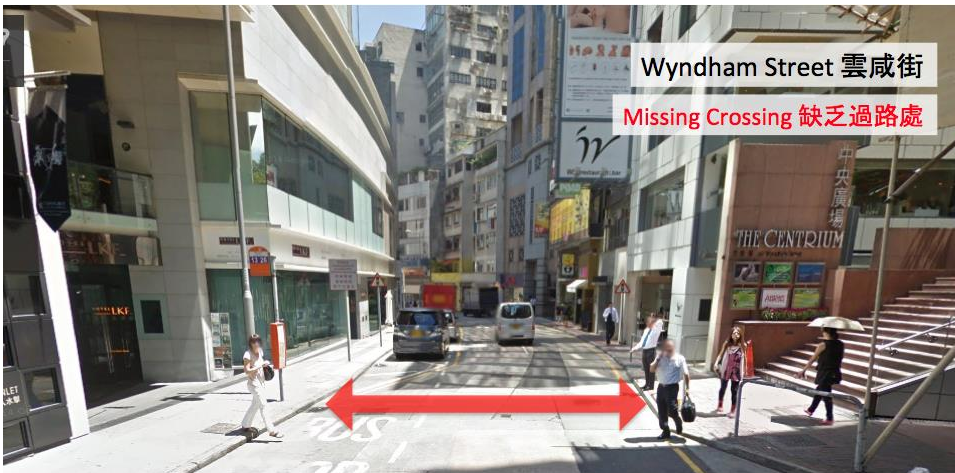
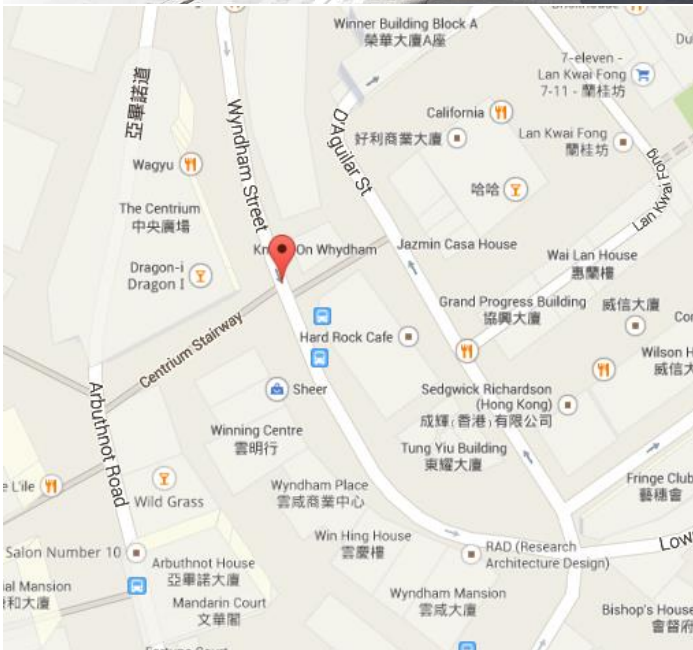
4.

Location: Wyndham Street and Centrium Stairway
Problem: Missing Crossing
Description: Missing crossing connect between Yau Shun Building and the Centrium staircase
Suggestion: Provide crossing at a place nearest to the arrow, bus stop may have to be relocated

位置: 雲咸街與中央廣場樓梯處
問題: 缺乏過路處
詳情: 缺乏過路處連接友信大廈及樓梯
建議: 重設巴士站並提供過路處於箭咀位置

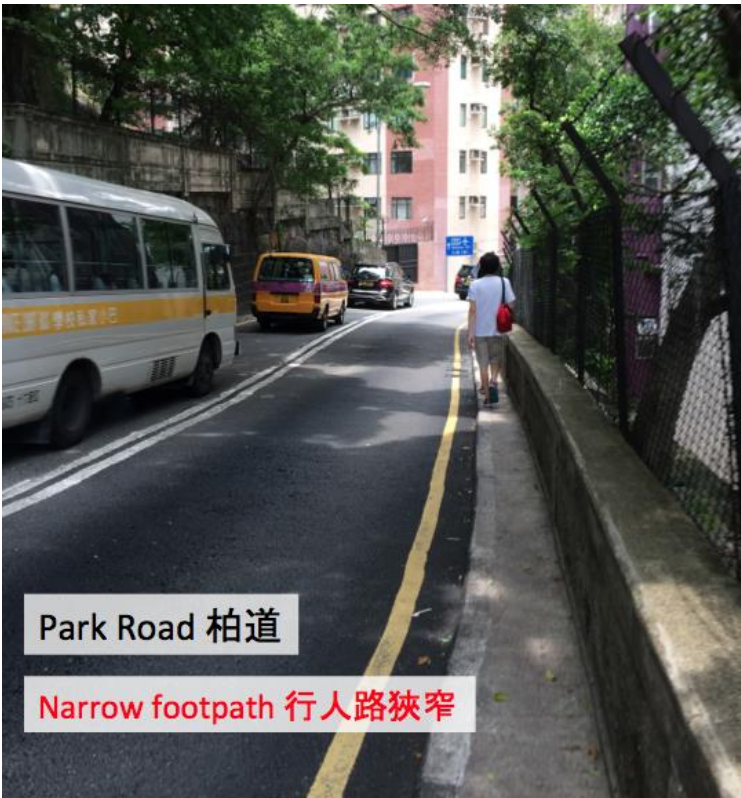
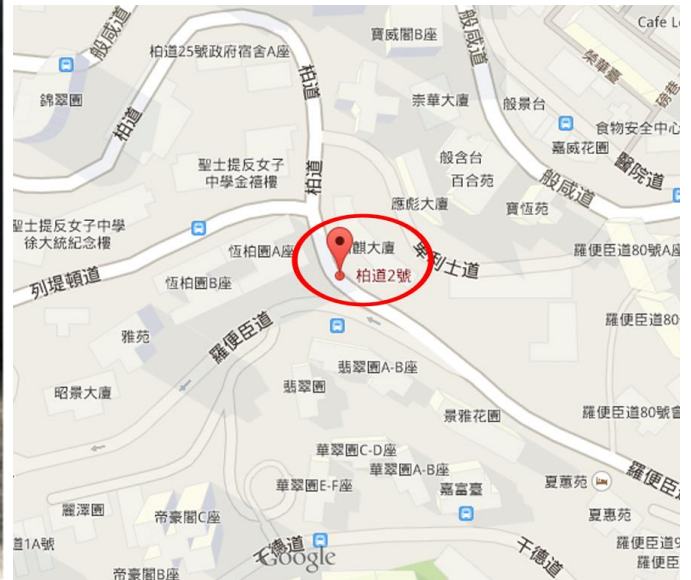
5.
Location: Park Road
Problem: Narrow Footpath
Description: Narrow Footpath between Robinson Road and Lyttelton Road
Suggestion: Widen pavement.

- 位置: 柏道
問題: 行人路狹窄
詳情: 羅便臣道與列堤頓道之間的行人路狹窄
建議: 擴闊行人路

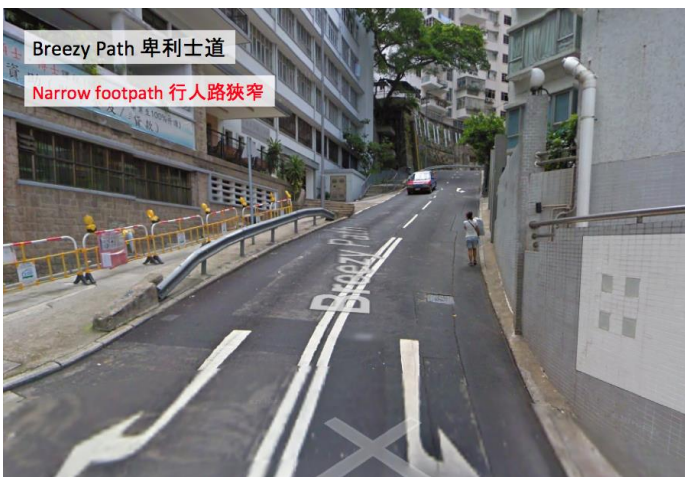
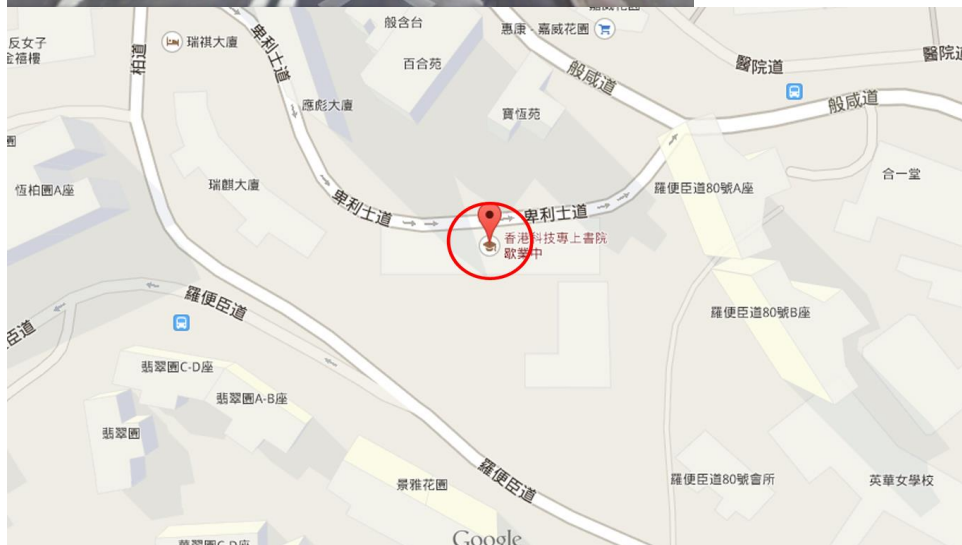
6.

Location: Breezy Path
Problem: Narrow footpath
Description: The traffic flow is high, and the footpath is narrow
Suggestion: Narrow down the footpath of Hong Kong Institute of Technology side and widen the other side footpath

位置: 卑利士道
問題: 行人路狹窄
詳情: 汽車道路比較繁忙，而且行人道狹窄。
建議: 收窄香港科技專上學院旁的行人路擴闊另一方行人路

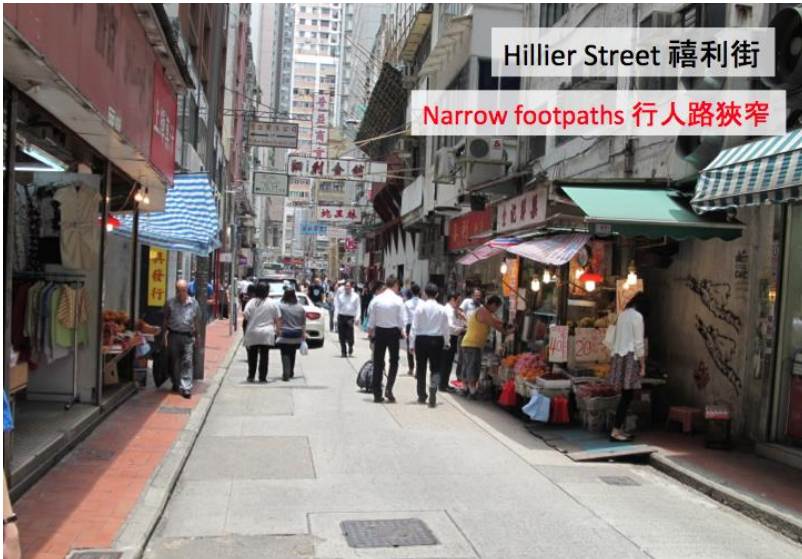
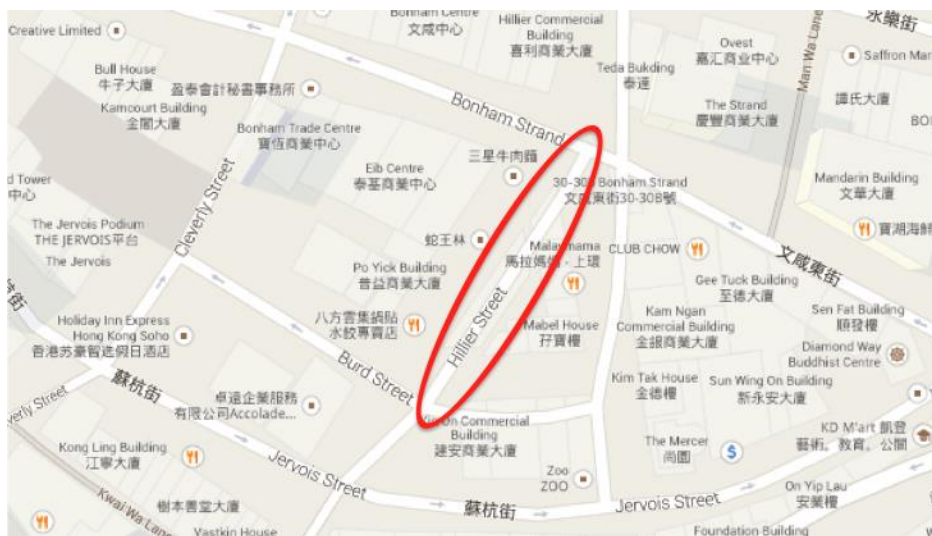
7.
Location: Hillier Street
Problem: Narrow footpath
Description: People walk on the road because of narrow footpaths
Suggestion: Level down the footpath. Prioritise pedestrian use. (e.g. shared surface)

位置: 禧利街
問題: 狹窄行人路
詳情: 行人多在行車路上走動
建議: 將行人路整平, 並列禧利街為行人優先使用。(例如設置車輛行人共用區)

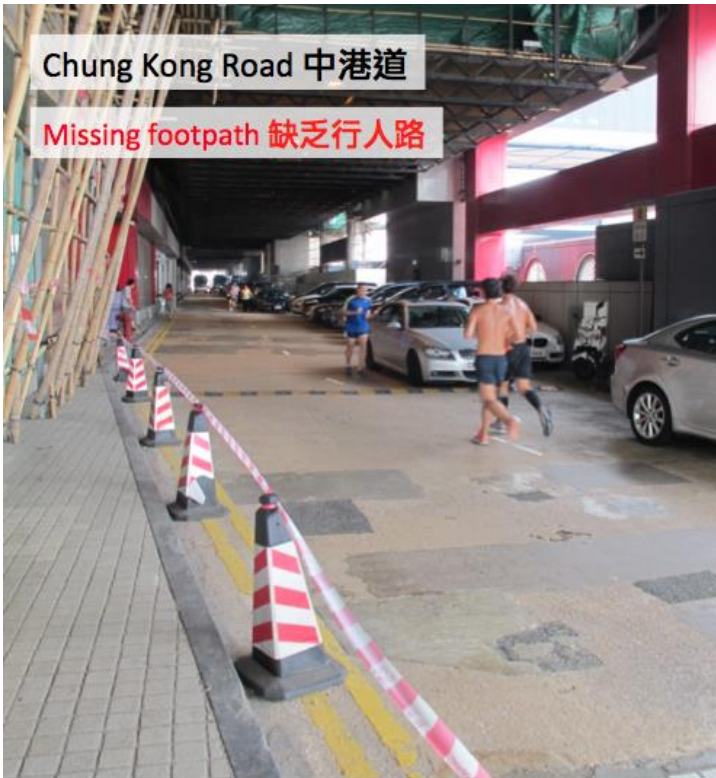
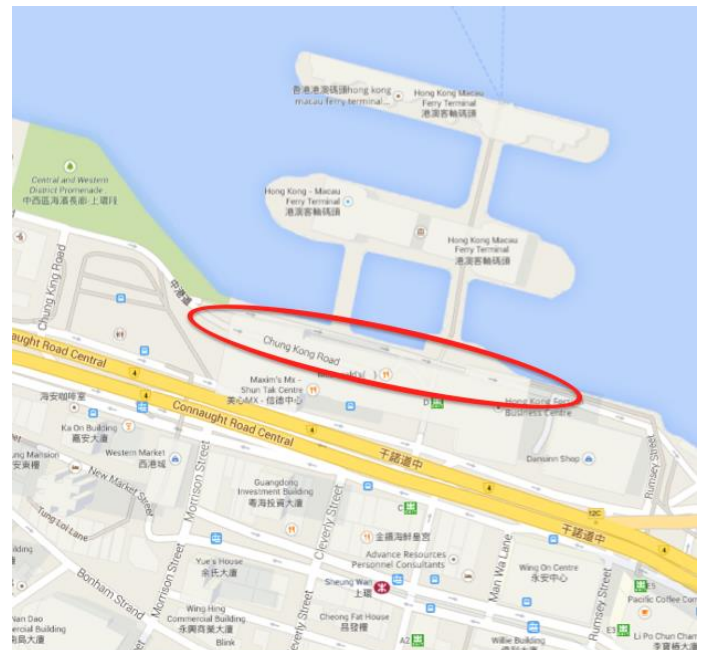
8.
Location: Chung Kong Road (under Shun Tak Centre)
Problem: Missing footpath
Description: Missing footpath for people running alongside the harbour front
Suggestion: Provide footpath

位置: 中港道(信德中心)
問題: 缺乏行人路
詳情: 缺乏行人路予跑步人士沿著海濱跑步
建議: 提供行人路

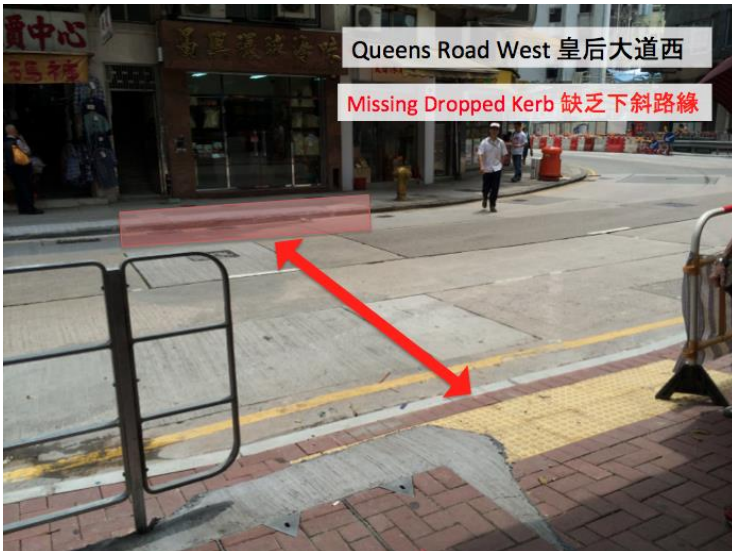
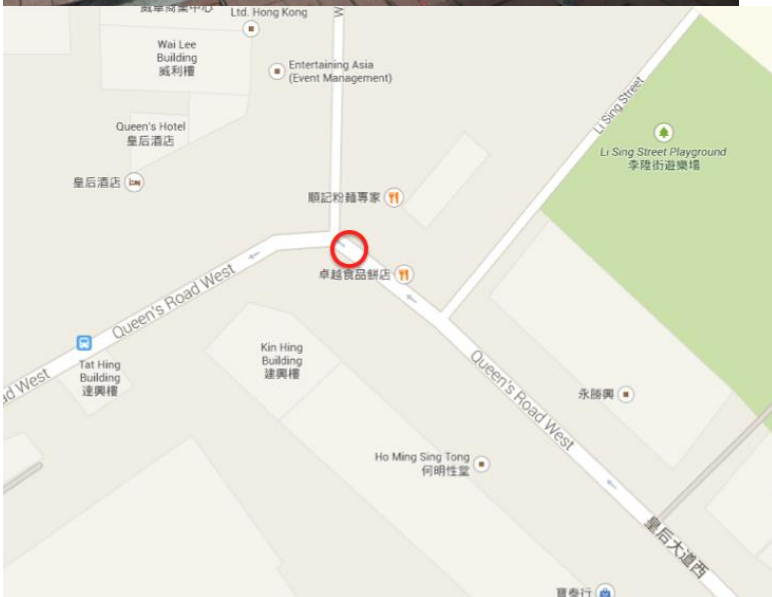
9.
Location: Queens Road West (near Li Sing Street)
Category: Missing dropped kerb
Problem: Dropped kerb is only present on one side of the road
Suggestion: Provide dropped kerb at one side and 'Look left/right' markings on both sides

- 位置: 皇后大道西(李星街)
問題: 缺乏下斜路緣
詳情: 只有一邊行人路上設有下斜路緣及行人輔助線
建議: 在對面的行人路增設下斜路緣、並增設道路標記及行人輔助線於兩旁

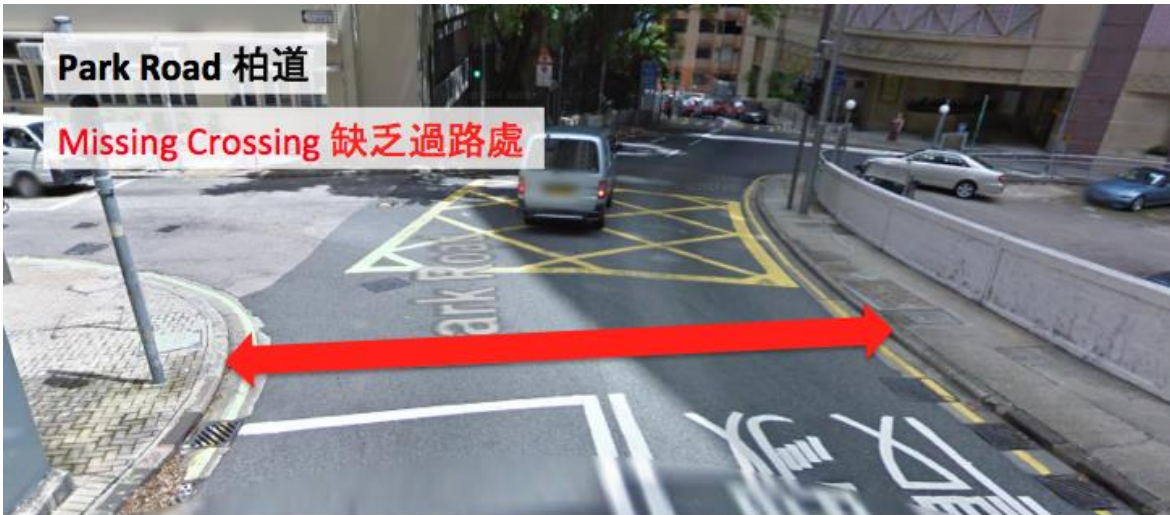
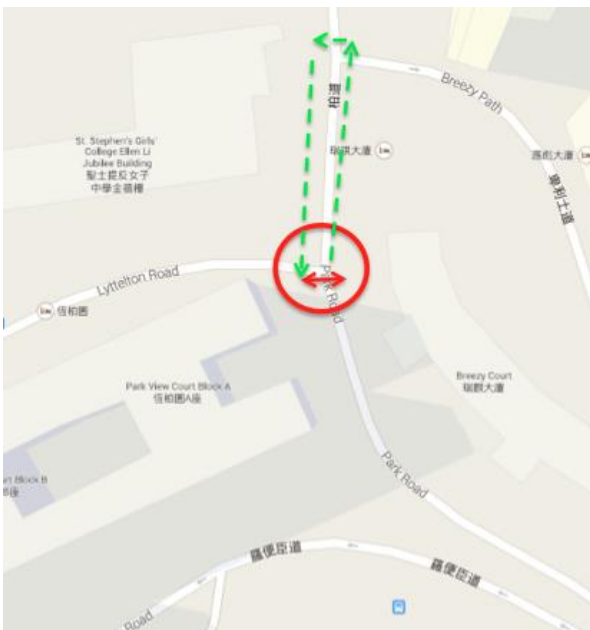
10.

Location: Intersection of Park Road and Lyttelton Road
Problem: Missing crossing
Description: There is a missing crossing from Park Road to Lyttelton Road.
Suggestion: Provide crossing.

位置: 柏道與列堤頓道交界
問題: 缺乏過路處
詳情: 缺乏過路處連接柏道及列堤頓道。
建議: 提供過路處

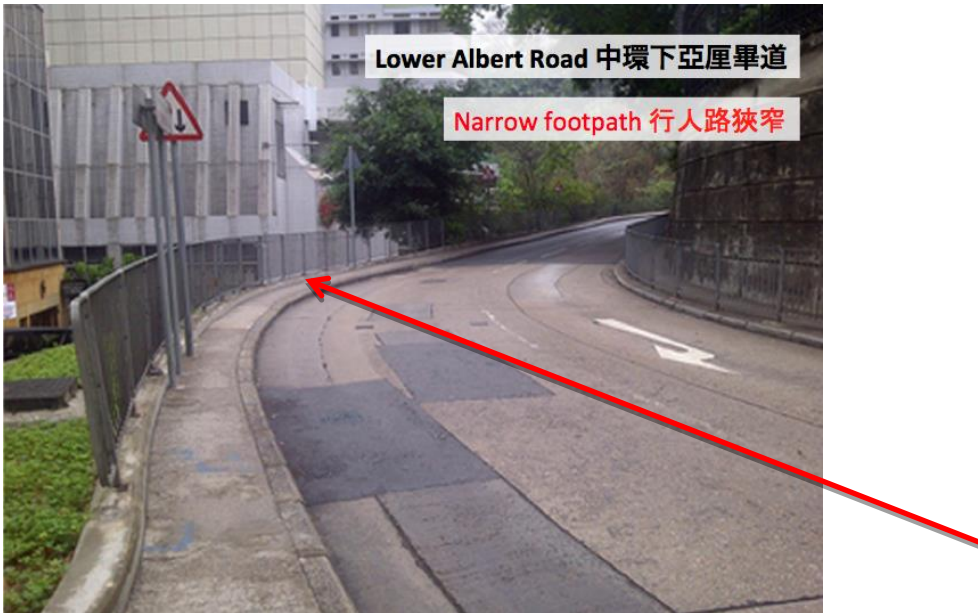
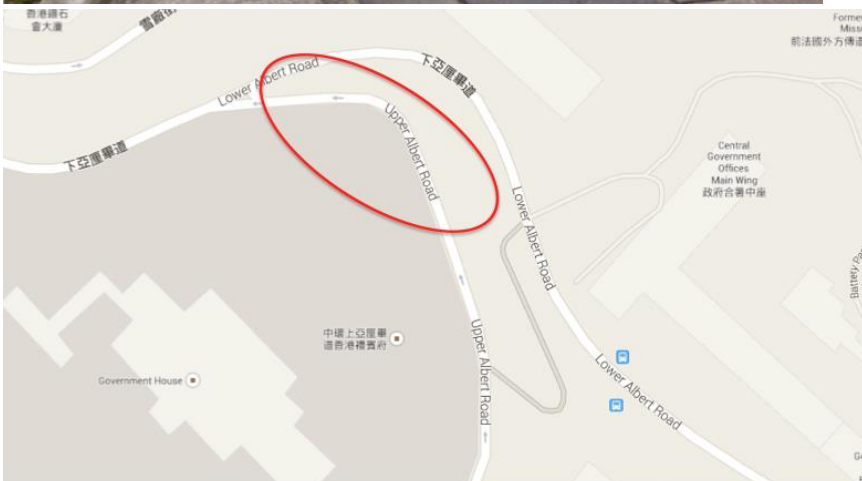
11.
Location: Lower Albert Road
Problem: Narrow footpath
Suggestion: Widen pavement, it may be possible to extend the footpath to the slope

位置: 中環下亞厘畢道
問題: 狹窄行人路
建議: 擴闊行人路，亦可能將行人路延伸至側邊的斜坡

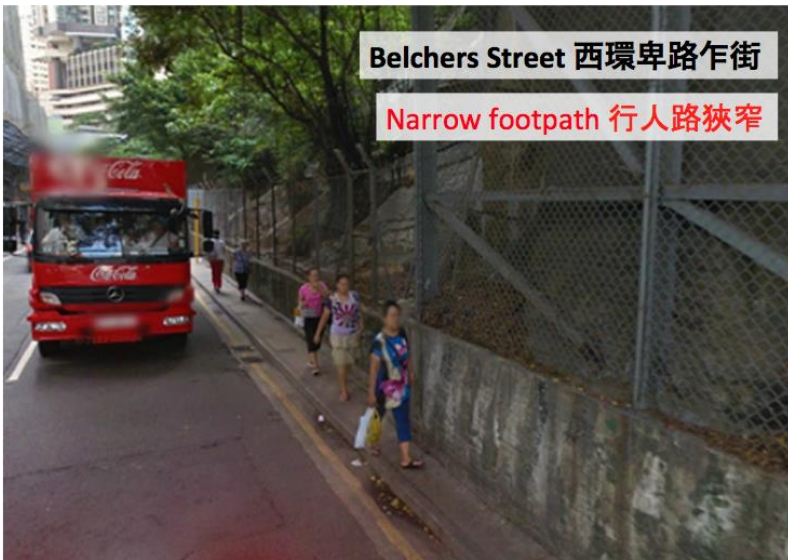
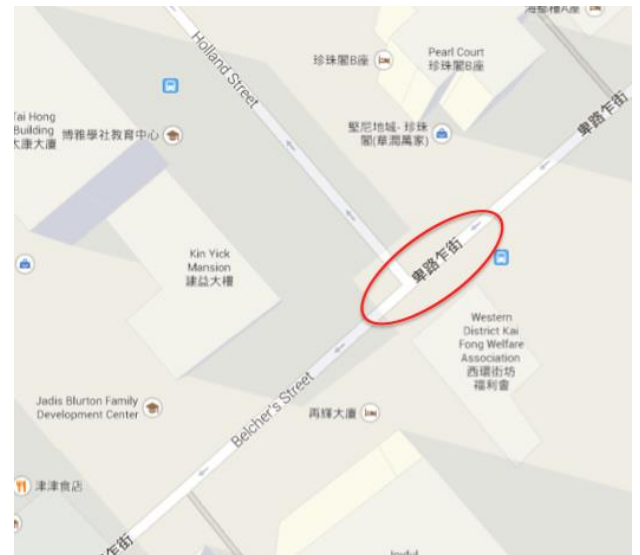
12.

Location: Belcher's Street
Problem: Narrow footpath
Suggestion: Widen pavement

位置: 西環卑路乍街
問題: 狹窄行人路
建議: 擴闊行人路

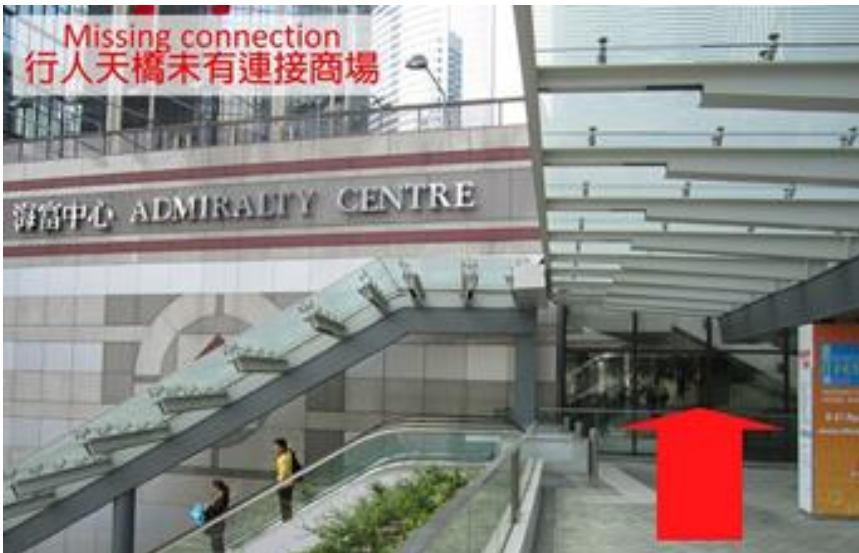
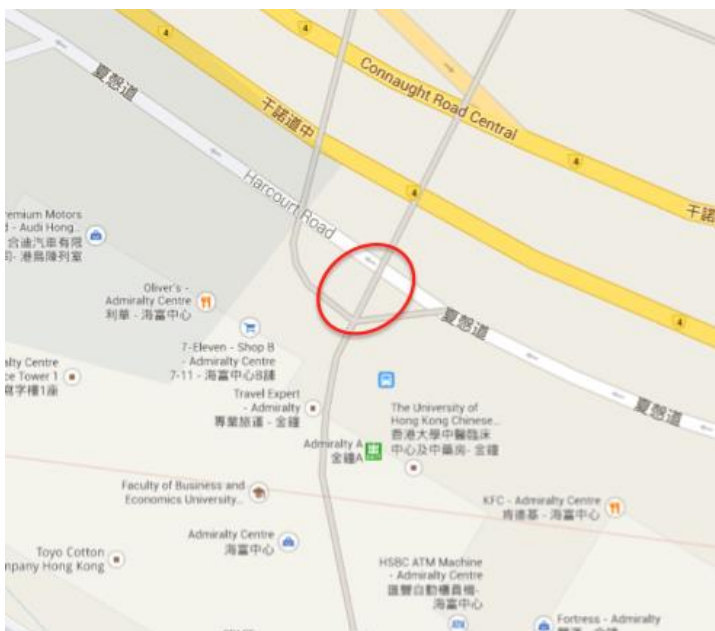
13.

Location: Tamar Footbridge, Harcourt Road
Problem: Missing Connection to Admiralty Centre
Suggestion: Provide connection with Admiralty Centre

位置: 夏慤道, 添馬艦行人天橋
問題: 行人天橋未有連接商場
建議: 行人天橋應連接海富中心

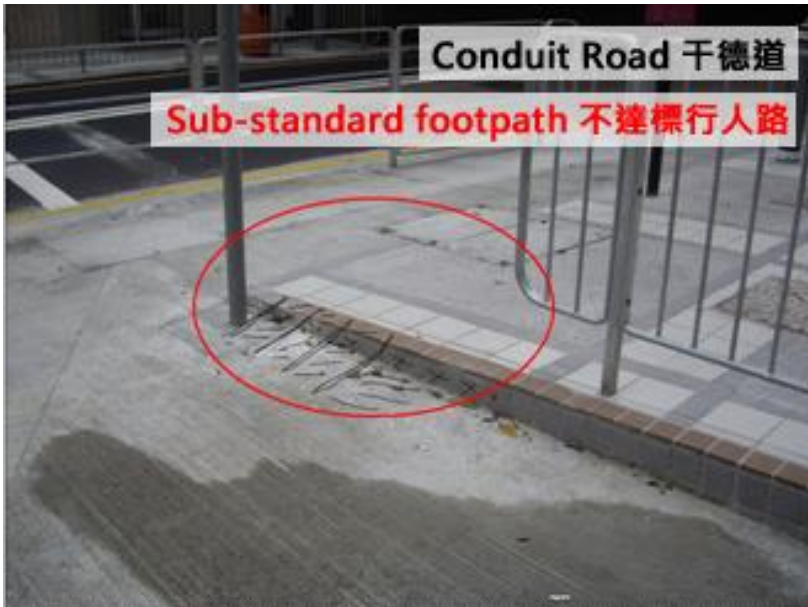
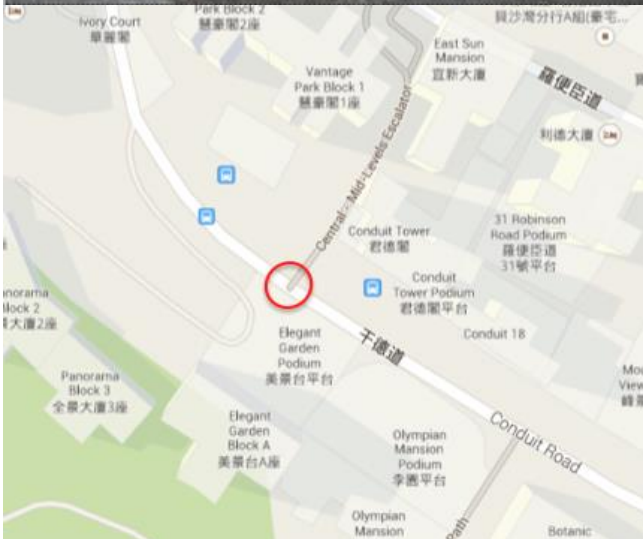
14.

Location: Conduit Road Escalator Exit
Problem: Sub-standard footpath
Description: There is a level difference in the footpath
Suggestion: Fill up the level difference

位置: 半山干德道扶手電梯出口處
問題: 不達標行人路
詳情: 行人路不平
建議: 整平行人路

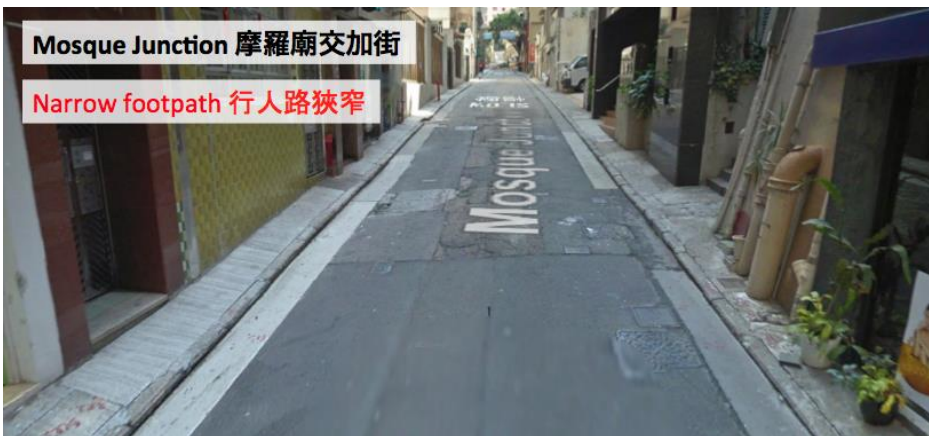
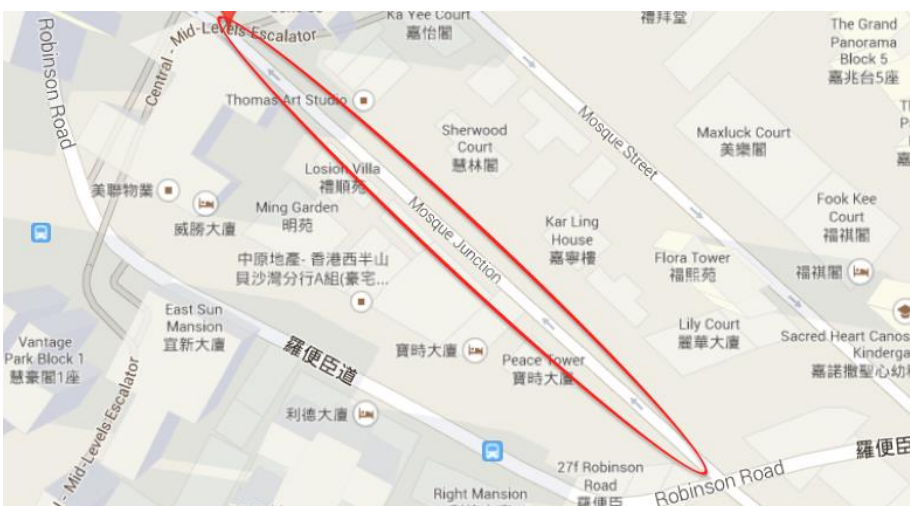
- 15.
- Location: Mosque Junction
Problem: Narrow footpath
Description: Narrow footpath on both sides with cars sometimes parking on the footpath
Suggestion: Prioritise pedestrian use. (e.g. shared surface, road lane markings, bollards as necessary, etc)

- 位置: 摩羅廟交加街
問題: 狹窄行人路
詳情: 兩側狹窄的行人路，有時車輛停泊在行人道上
建議: 列為行人優先使用(例如設置車輛行人共用區、泳線標記、短柱等)

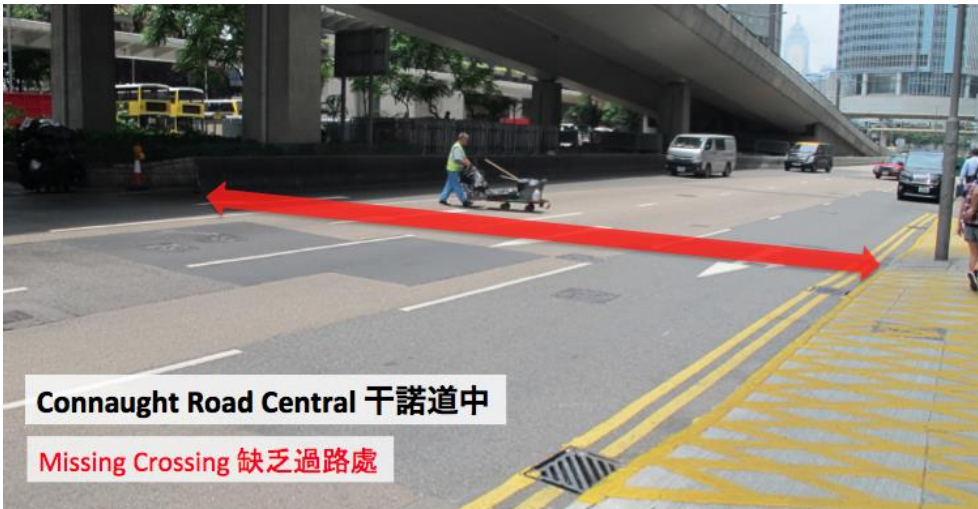
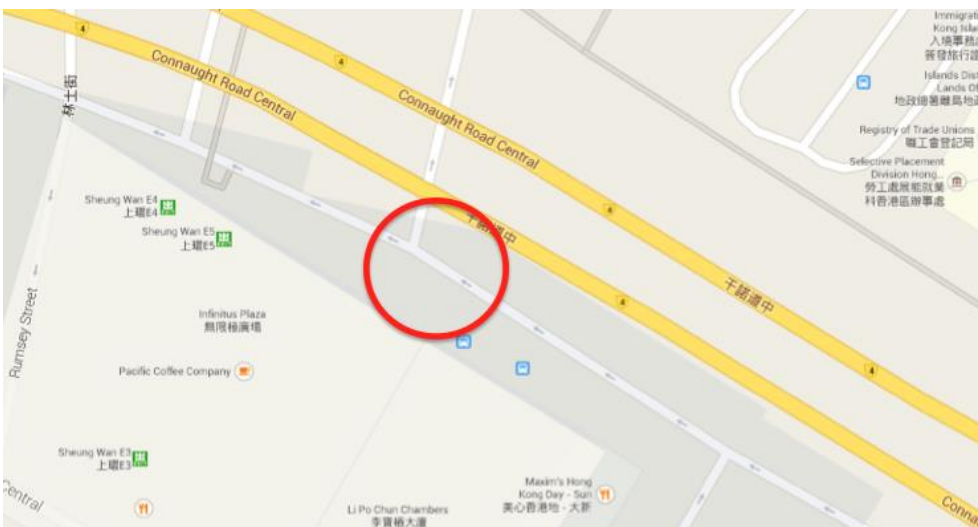
16.
Location: Connaught Road near Wing Wo Street
Problem: Missing crossing
Description: Missing crossing connection with the bus stop and the refuse collection point
Suggestion: TD to study improvement proposals

- 位置: 干諾道中旁的永和街
問題: 缺乏過路處
詳情: 缺乏過路處連接巴士站及垃圾收集站
建議: 請運輸署研究解決方法

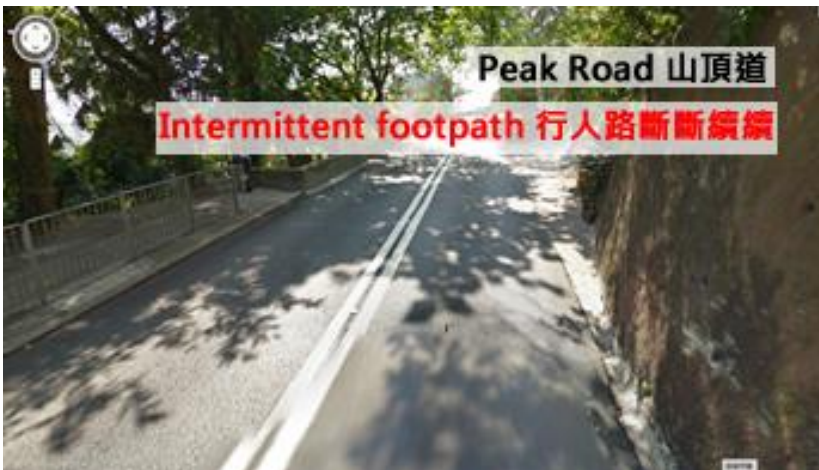
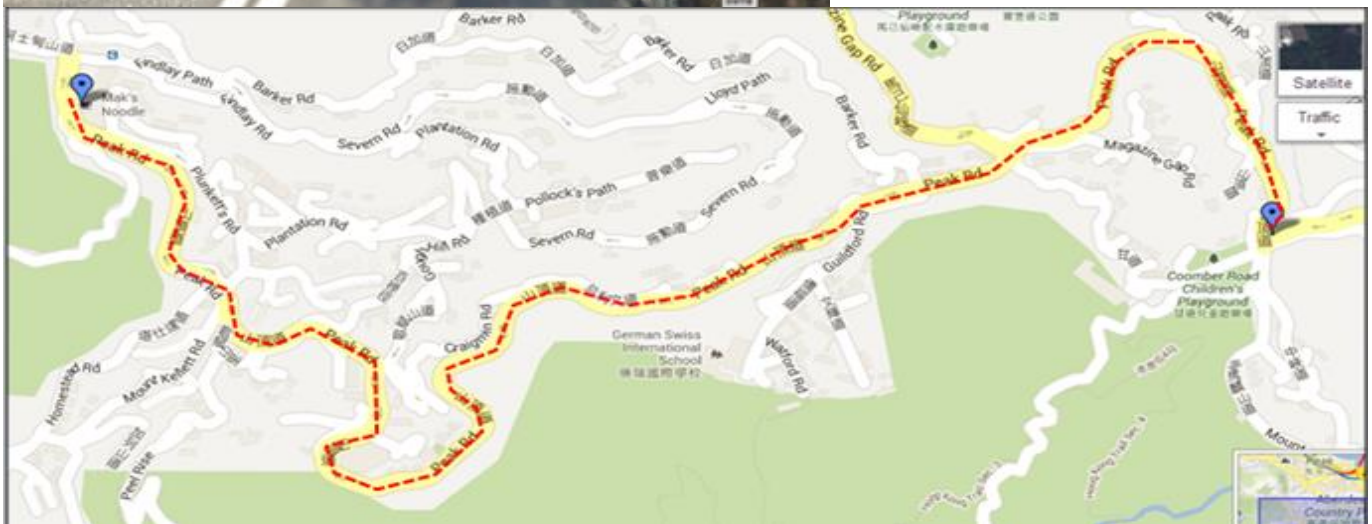
- 17.
- Location: Peak Road
- Problem: Missing and narrow footpath
- Description: Missing and narrow footpath at various sections
- Suggestion: 1) Request slope maintenance agents to provide a non-standard width footpath as and when there are slope works
2) Identify the roads concerned and make it 'shared surface' (e.g. Coombe Road)

- 位置: 山頂道
- 問題: 缺乏及狹窄行人路
- 詳情: 某止路段缺乏及狹窄行人路
- 建議: 1) 要求斜坡維修承建部門進行斜坡工程時，一併提供擴闊行人路的工程
2) 設置車輛行人共同區 (例如：甘道)

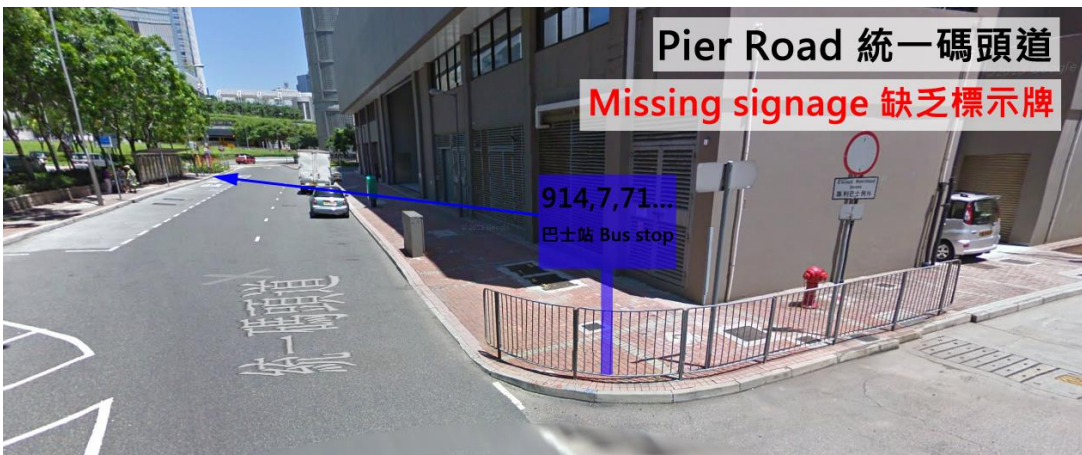
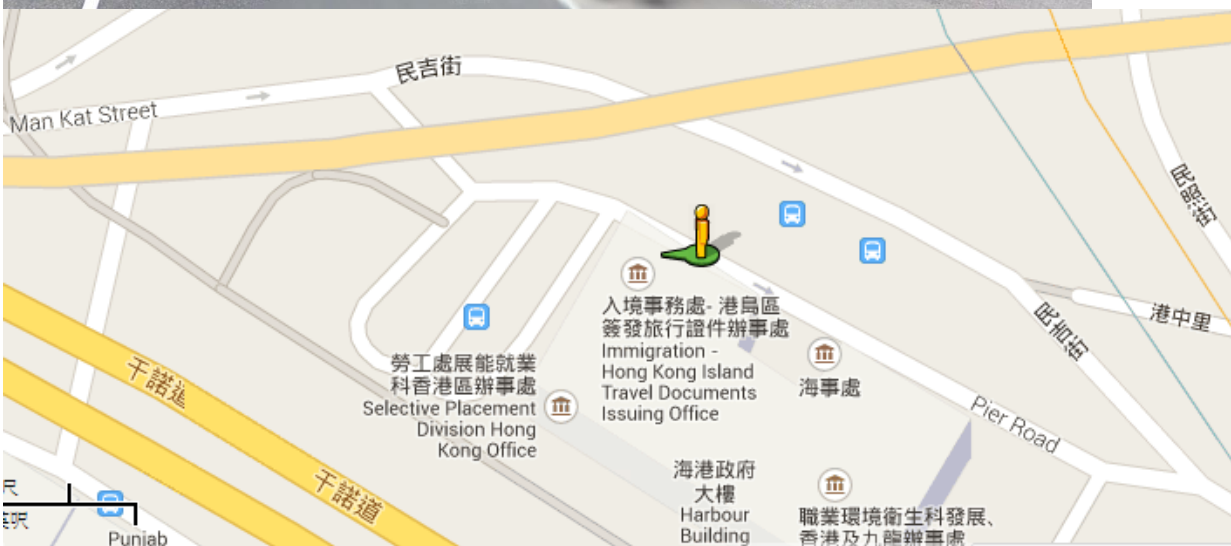
18.
Location: Bus Stop outside Harbour Building to the outlying Islands Piers
Problem: Missing signage
Description: Missingsignages to direct footbridge users to the bus stop of 914, 7, 71, etc
Suggestion: Provide signages

- 位置: 港灣道對出巴士站
問題: 缺乏標示牌
詳情: 缺乏標示牌指示 914,7,71 巴士站的位置
建議: 提供標示牌
