北區區內不合標準和缺乏連接的行人路

Missing and sub-standard pedestrian connections in the North District

1.

Location: San Wan Road near Fanling Wai

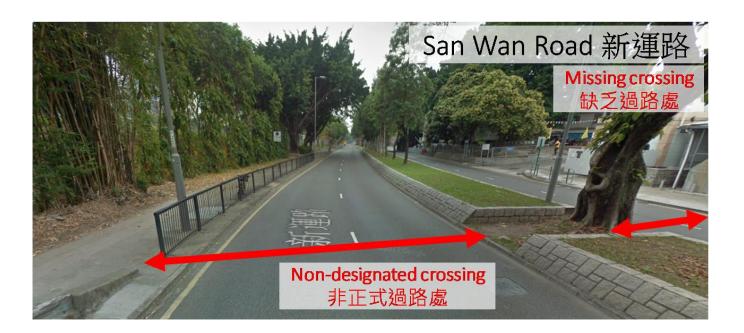
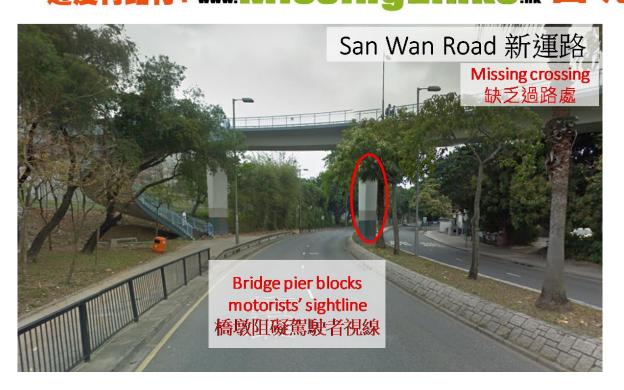
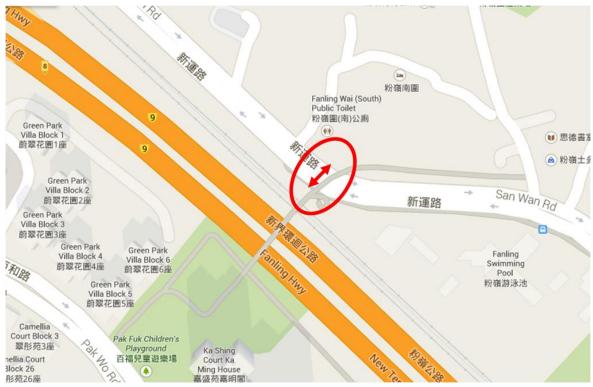
Problem: Missing crossing

Description: People cross informally at non-designated crossing including blind spots for

approaching motorists. The distant and tall footbridge is inconvenient for users,

especially elders, and there are insufficient crossings along this road.

Suggestion: Provide zebra crossing with Belisha beacon and road markings, or other crossing

as deemed appropriate, to connect Fanling Wai and San Wan Road Northbound including Fanling Swimming Pool, as well as signs for motorists to slow down.
